Memo

Date: August 7, 2021
To: QCDD Board of Supervisors
From: Albert Lopez
Re: Lake Repairs Initial Programming Report
CPH Job No.: Q0504

INITIAL REPAIRS
PROGRAMMING EXHIBIT

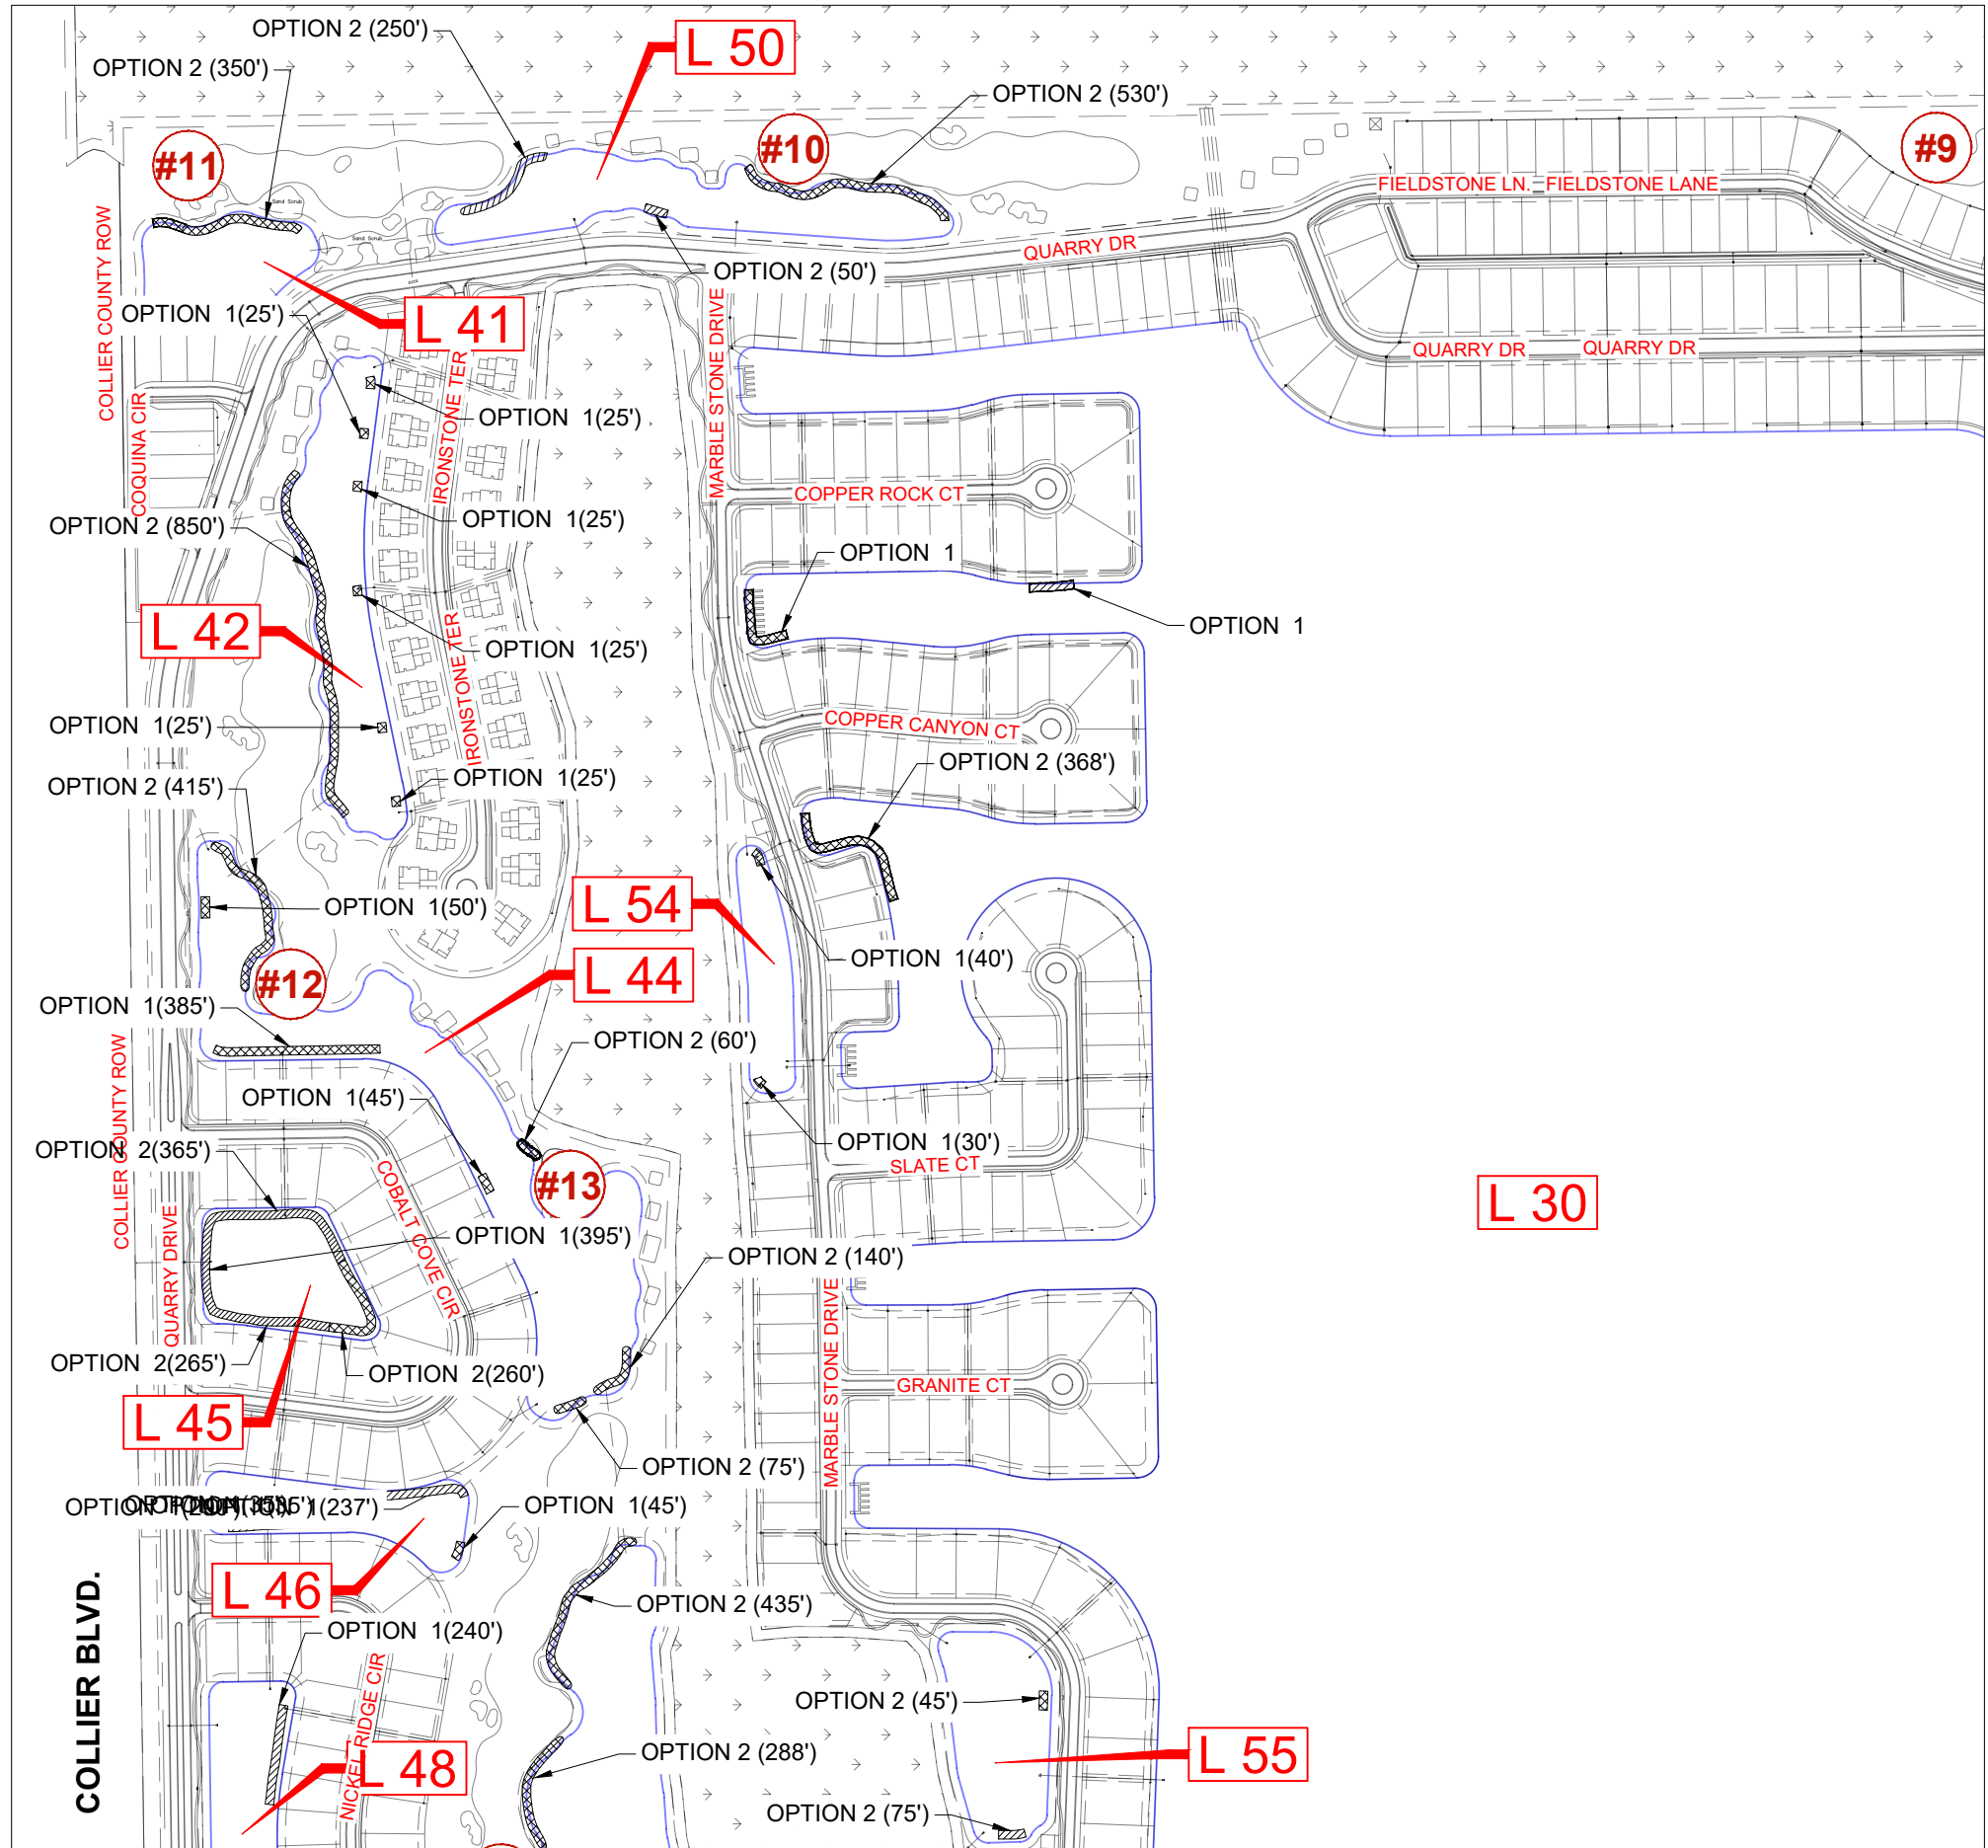
Sheet No.
EX-1

All areas preliminarily identified by CPH as potential Option 1 and Option 2 treatment areas are identified on the Initial Repairs Programming Exhibits
