THE QUARRY COMMUNITY DEVELOPMENT DISTRICT COLLIER COUNTY, FLORIDA

STORMWATER LAKES ANNUAL ASSESSMENT REPORT MAY 2021

THE QUARRY CDD STORMWATER LAKES ASSESSMENT REPORT COLLIER COUNTY, FLORIDA

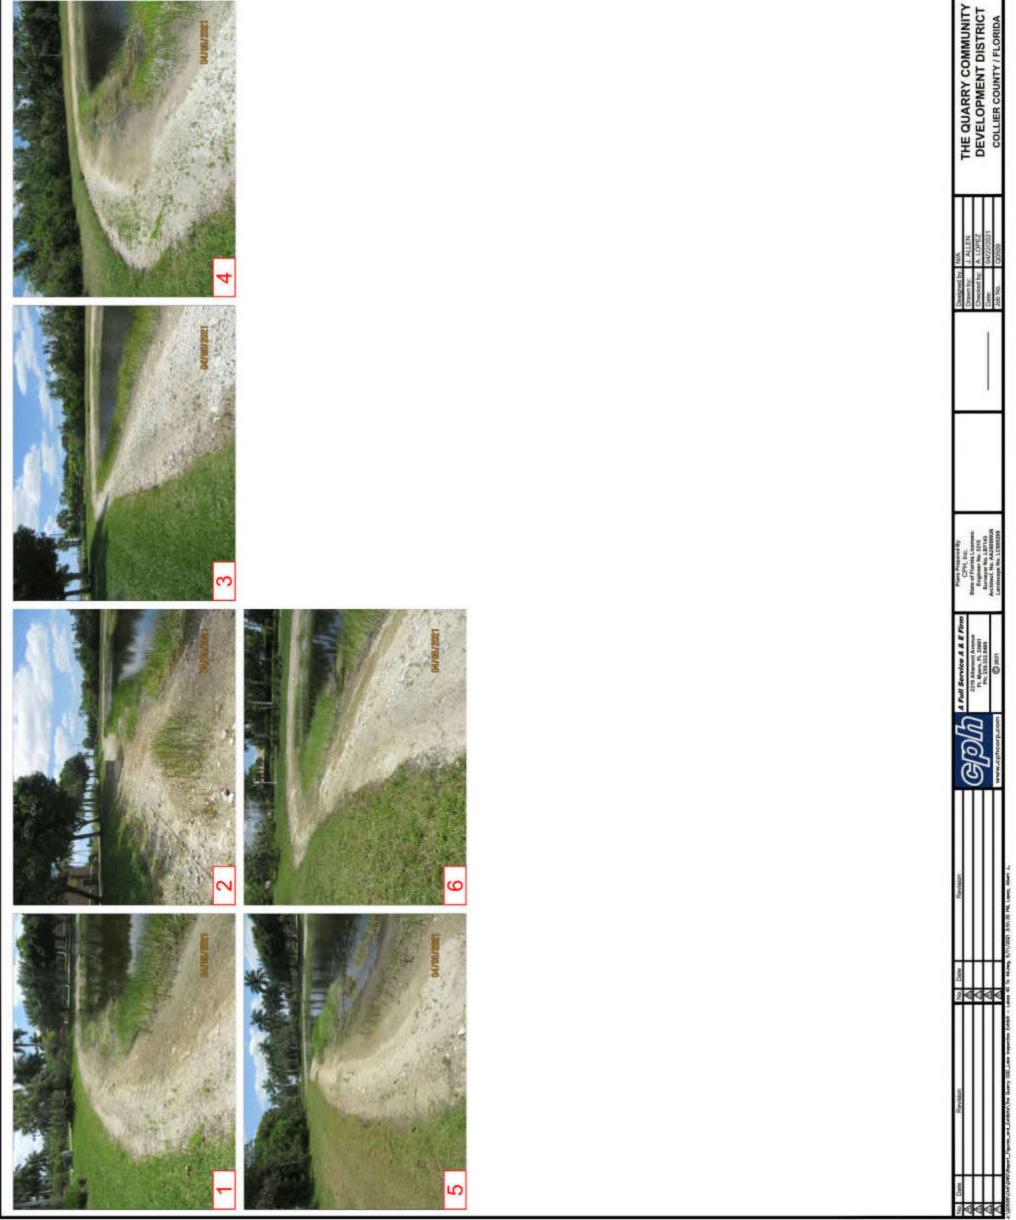
L49

- MINOR EROSION ADJACENT TO R.O.W. (PHOTO #4), APPROXIMATELY 100 LF.
- RECOMMENDATIONS TO MEET ORIGINAL INTENDED DESIGN:
 - RECONFIGURE 4:1 SLOPE WITH NEW FILL MATERIAL NEW FILL MATERIAL TO BE COMPACTED PER ORIGINAL DESIGN SPECIFICATIONS. .
- INSTALL 6"-8" RIPRAP LAYER AND KEY-WAY (6"-8") TO PROTECT LAKE BANK. ł.

- INTRODUCE THE USE OF LITTORAL PLANTING.
- THE USE OF LITTORAL PLANTING SHALL BE STARTED ON TESTING SPOTS TO CONFIRM PLANTS ADAPTATION AND SURVIVABILITY. .

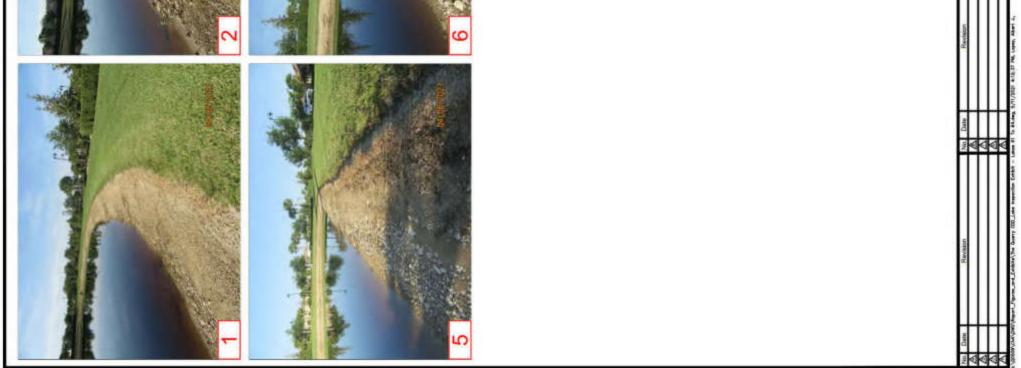
L62

- MODERATE EROSION ADJACENT TO R.O.W. (PHOTOS #1 - #3). APPROXIMATELY 110 LF.
- CONTROL STRUCTURE (L62L30) TOP COVERED WITH DEAD WEEDS AND GRASS CLIPPINGS.

- RECONFIGURE 4:1 SLOPE WITH NEW FILL MATERIAL NEW FILL MATERIAL TO BE COMPACTED PER ORIGINAL DESIGN SPECIFICATIONS.
 - INSTALL 6"-8" RIPRAP LAYER AND KEY-WAY (6"-8") TO PROTECT LAKE BANK.
 - CLEAN CONTROL STRUCTURE TOP GRATE.

- INTRODUCE THE USE OF LITTORAL PLANTING.
- THE USE OF LITTORAL PLANTING SHALL BE STARTED ON TESTING SPOTS TO CONFIRM PLANTS ADAPTATION AND SURVIVABILITY.

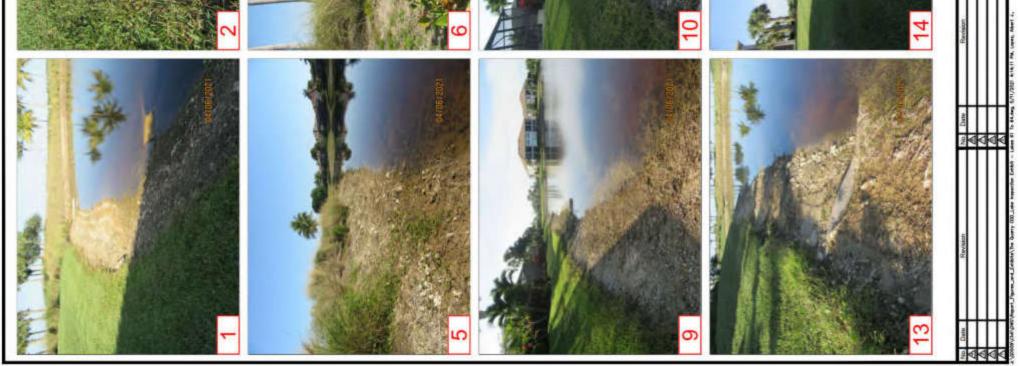
OBSERVATIONS	- MODERATE EROSION ADJACENT TO RESIDENTIAL PROPERTIES (PHOTOS #9 - #13). APPROXIMATELY 400 LF.	- CONTROL STRUCTURE (L63L30-1) TOP COVERED WITH TRASH.	RECOMMENDATIONS TO MEET ORIGINAL INTENDED DESIGN: DECOMPLICATED AT SUCCE WITH MEM FULL MATERIAL MEM	- RECONFIGURE 4.1 SLOTE WITH NEW FILL MATERIAL, NEW FILL MATERIAL TO BE COMPACTED PER ORIGINAL DESIGN SPECIFICATIONS. - INSTALL 6-8" RIPRAP LAYER AND KEY-WAY (6"-8") TO	PROTECT LAKE BANK CLEAN CONTROL STRUCTURE TOP GRATE.	ALTERNATE RECOMMENDATIONS INTRODUCE THE USE OF LITTORAL PLANTING.	 THE USE OF LITTORAL PLANTING SHALL BE STARTED ON TESTING SPOTS TO CONFIRM PLANTS ADAPTATION AND SURVIVABILITY. 	CONTROL STRUCTURE LB3L30-1		CONTROL STRUCTURE L63L30-2 260-17-101.31"N.1.81-940255.21"W	INITY LAKE BANK CONDITION SURVEY
		and the second s				4			12		
	When when he had a second and had a seco	and the second sec				3					R. R. Filmer Present Development By worken Burger Price Laconner Burger Price Action
