# Quarry Community Development District

**2022 SHORELINE (PHASE I & II)  
VEGETATION MONITORING REPORT**

**WATER QUALITY MONITORING REPORT**

1st Quarter 2023 – Field Management Report  
Inspection date 12-27-22

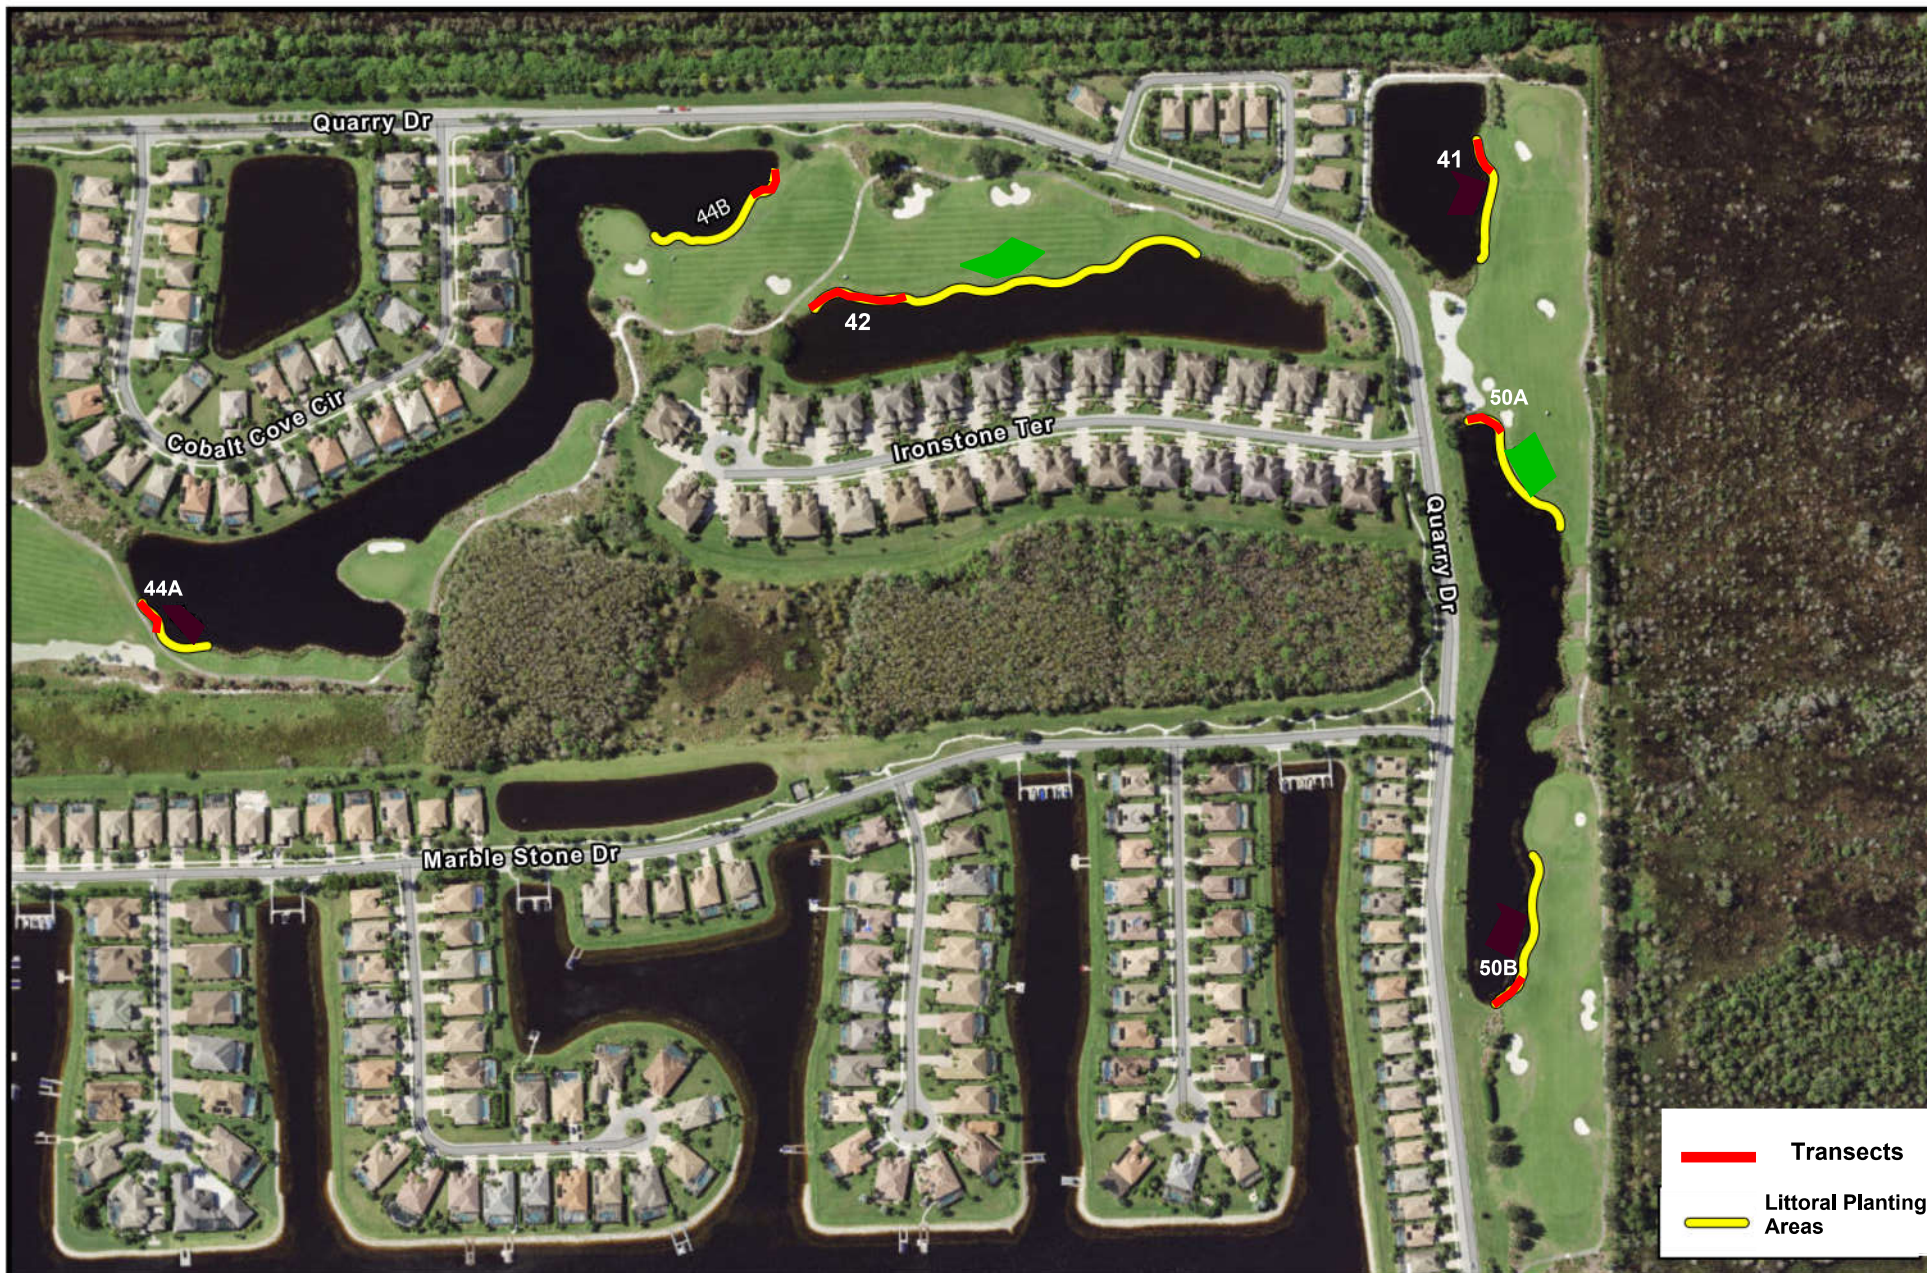
**FIGURE**  
**1B**

# TRANSECT LOCATION MAP THE QUARRY SECTION 14 & 23, TOWNSHIP 48 SOUTH, RANGE 26 EAST COLLIER COUNTY, FLORIDA

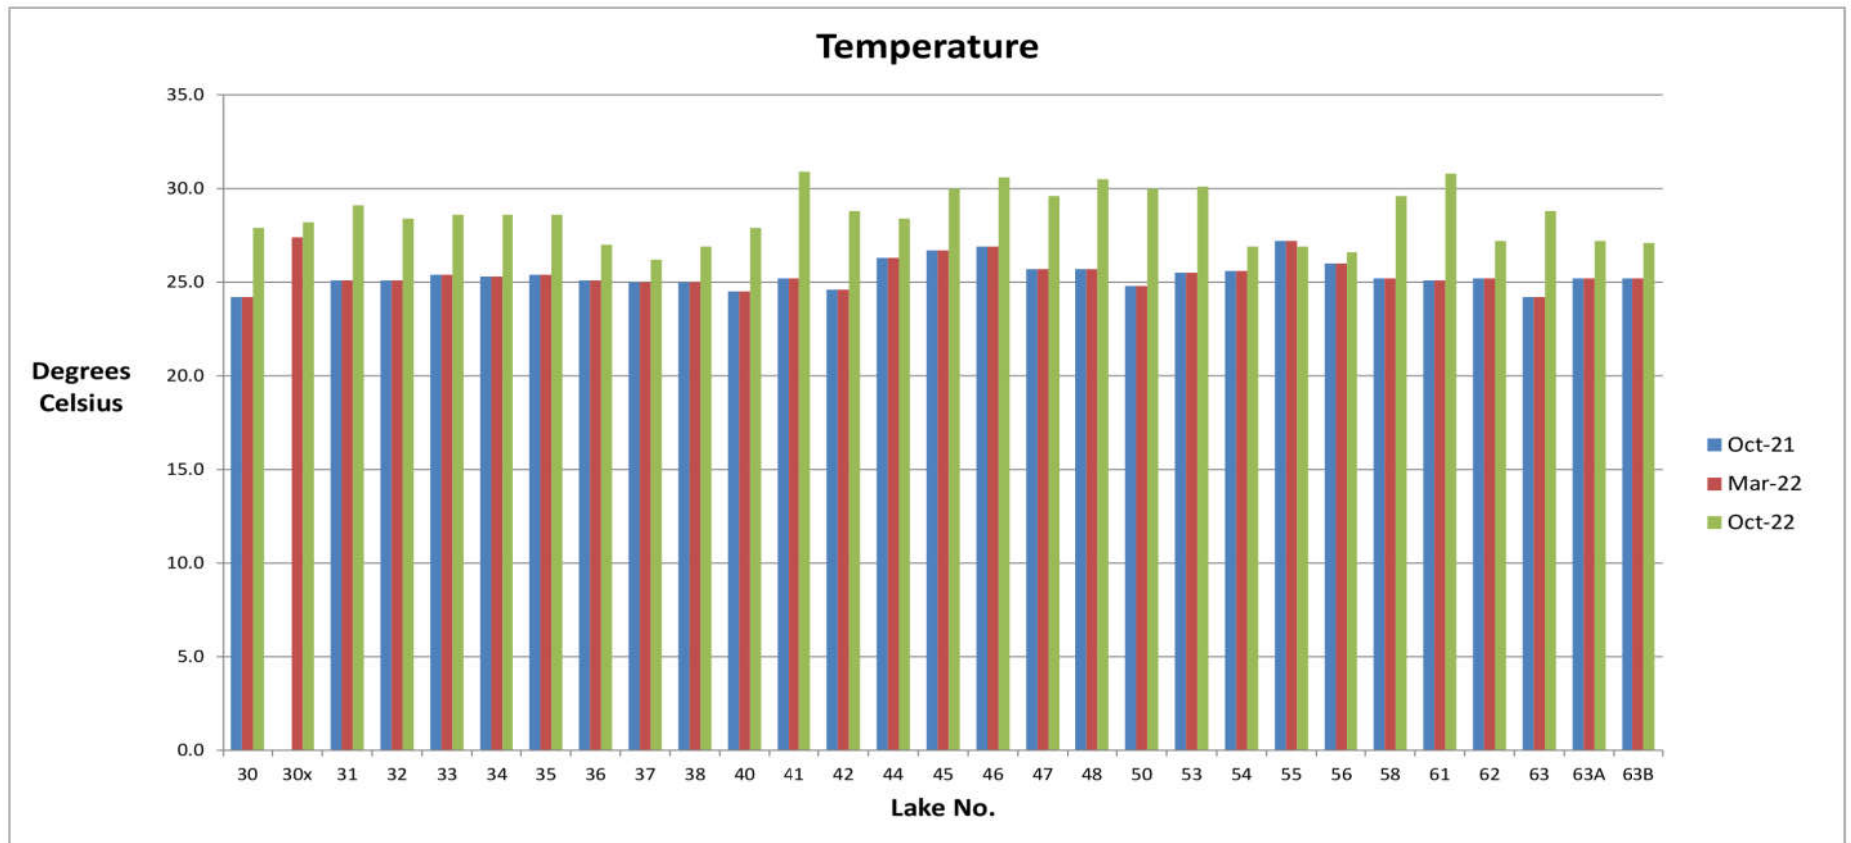
**FIGURE  
3**

Normal temperature for freshwater lakes in Florida ranges from 24° - 30° Celsius (annual average). Temperature is used in analysis of dissolved oxygen values. Extremely high temperature can contribute to low oxygen levels, leading to fish kills. Extremely low temperature could kill aquatic organisms. Lake temperatures in October 2022 ranged from 26.2 – 30.9°C, which is normal for the time of year. The temperature measurements in all lakes for the last three monitoring events are shown in **Figure 3, Appendix A**.

Normal Range = 24 Degrees - 30 Degrees C (Annual Average)

#### TEMPERATURE MEASUREMENTS OCT 2021 - OCT 2022

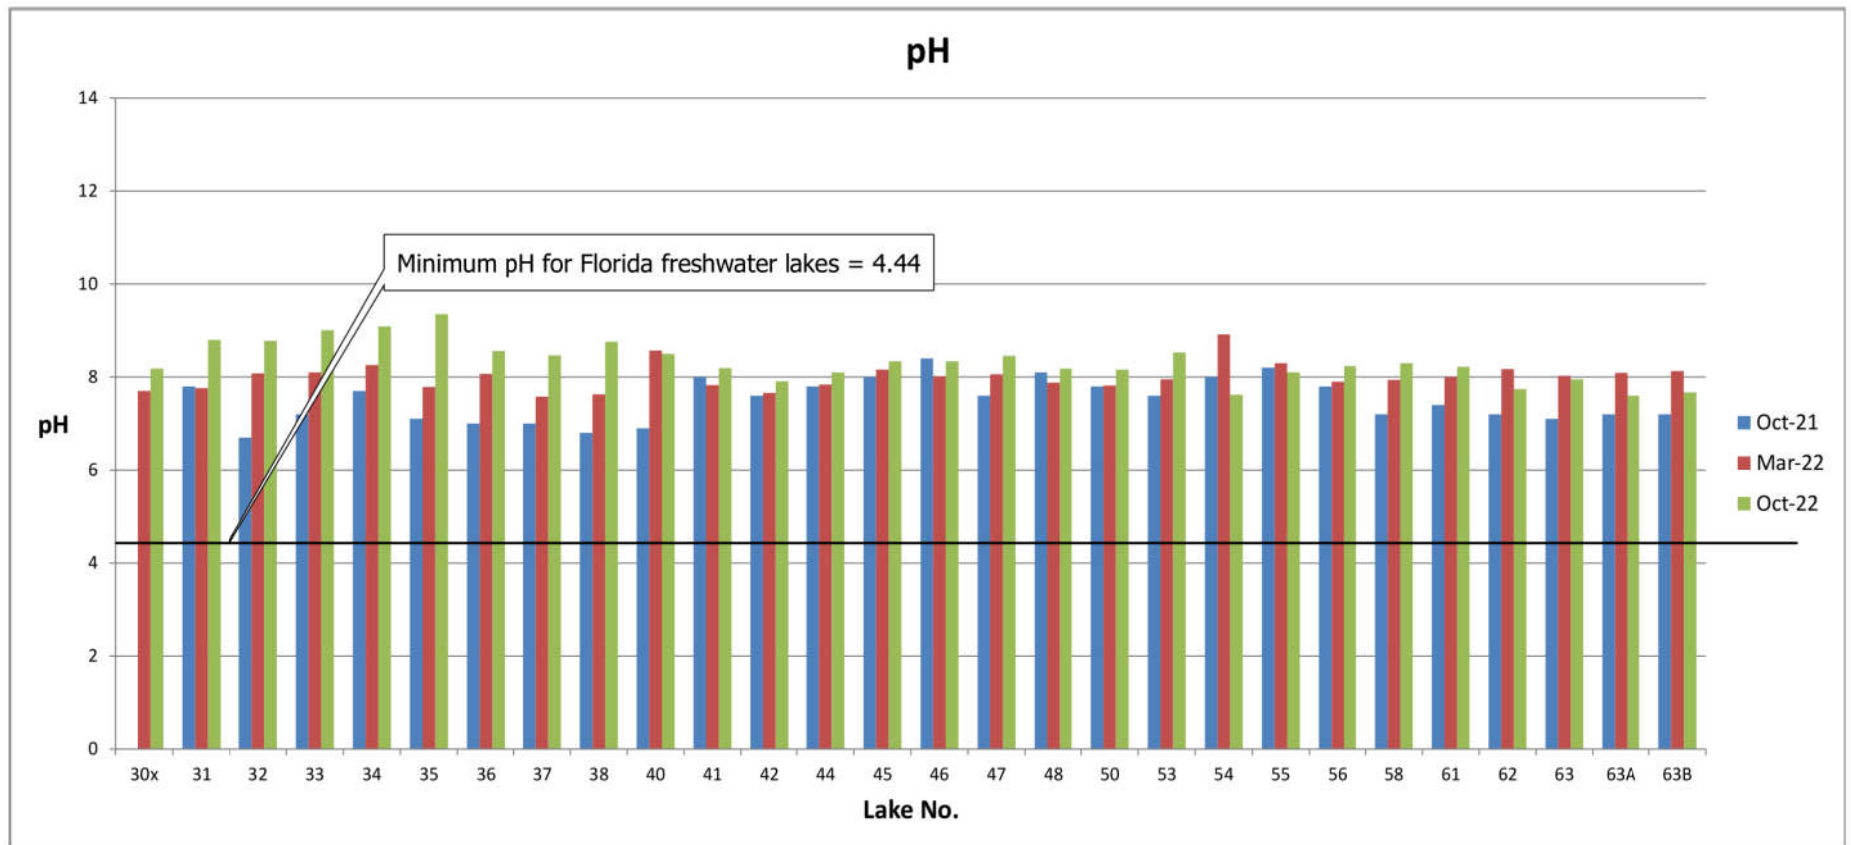
**FIGURE  
4**

The pH of the CDD lakes during the October 2022 monitoring event were within the normal range for south Florida lakes, ranging from 7.6 to 9.4. The pH of all lakes for the last three monitoring events are shown in **Figure 4, Appendix A**.

## PH MEASUREMENTS OCT 2021 - OCT 2022

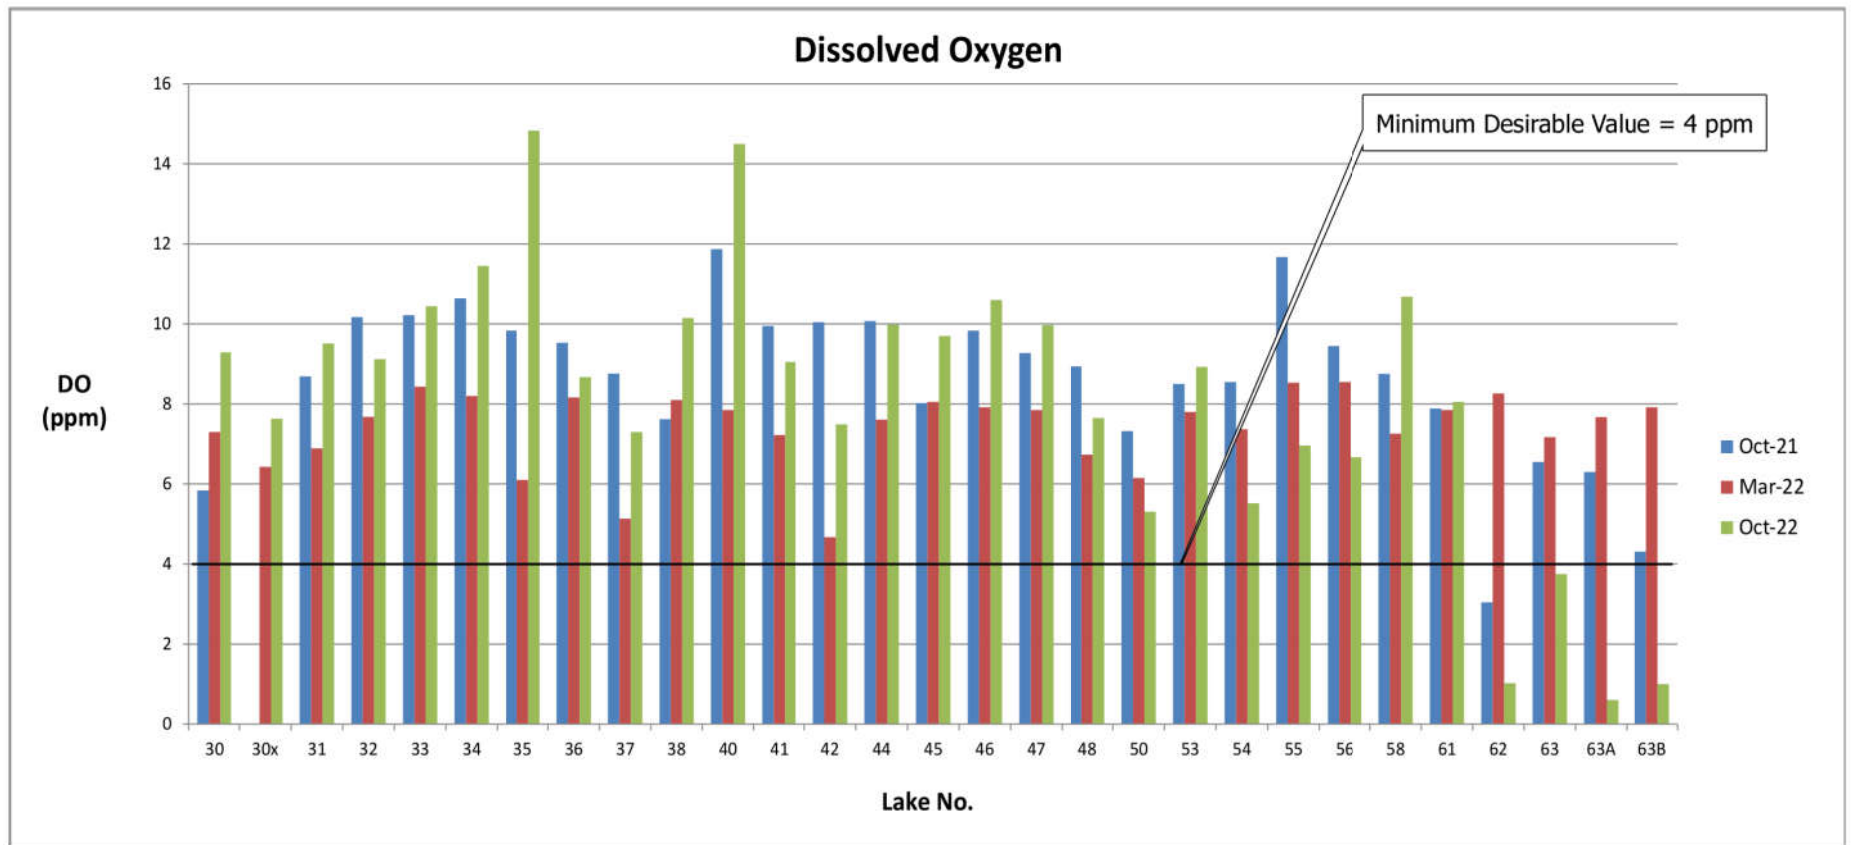
**FIGURE  
5**

During the monitoring event in October 2022, DO levels in the lakes ranged from 0.60 – 14.83 parts per million (ppm). The observed DO concentrations were normal and

sufficient to sustain fish and other aquatic organisms in all lakes except Lake 62, 63, 63A and 63B which had DO levels below 4 ppm. These four lakes are on the eastern edge of the community. The results of any laboratory measurement are a snapshot of the conditions at the time the sample was collected. As mentioned previously, the amount of oxygen in a water body is variable over time and can be affected by numerous external factors. The October 2022 monitoring was conducted approximately one week after Hurricane Ian passed through southwest Florida, bringing high wind and extremely high rainfall. Localized flooding was widespread and evidence of flooding was observed in the conservation area near the lakes with low DO levels. Flooding due to the hurricane may have contributed to a temporary drop in DO levels. During the October 2022 water quality sampling, there was no visible evidence that low oxygen was affecting aquatic life in any of the CDD lakes.

The dissolved oxygen levels in all lakes for the last three monitoring events are shown in **Figure 5, Appendix A.**

#### DISSOLVED OXYGEN MEASUREMENTS OCT 2021 - OCT 2022

- The observed DO concentrations in Lakes 62, 63, 63A and 63B were below 4 ppm. Sustained or chronically low DO levels are not conducive to a healthy population of aquatic organisms. During the October 2022 water quality sampling, there was no visible evidence that low dissolved oxygen was affecting aquatic life. The low DO levels observed in these four lakes may be attributable to extremely high rainfall and flooding that occurred in the week prior to the monitoring event. Therefore, no action is recommended at this time.

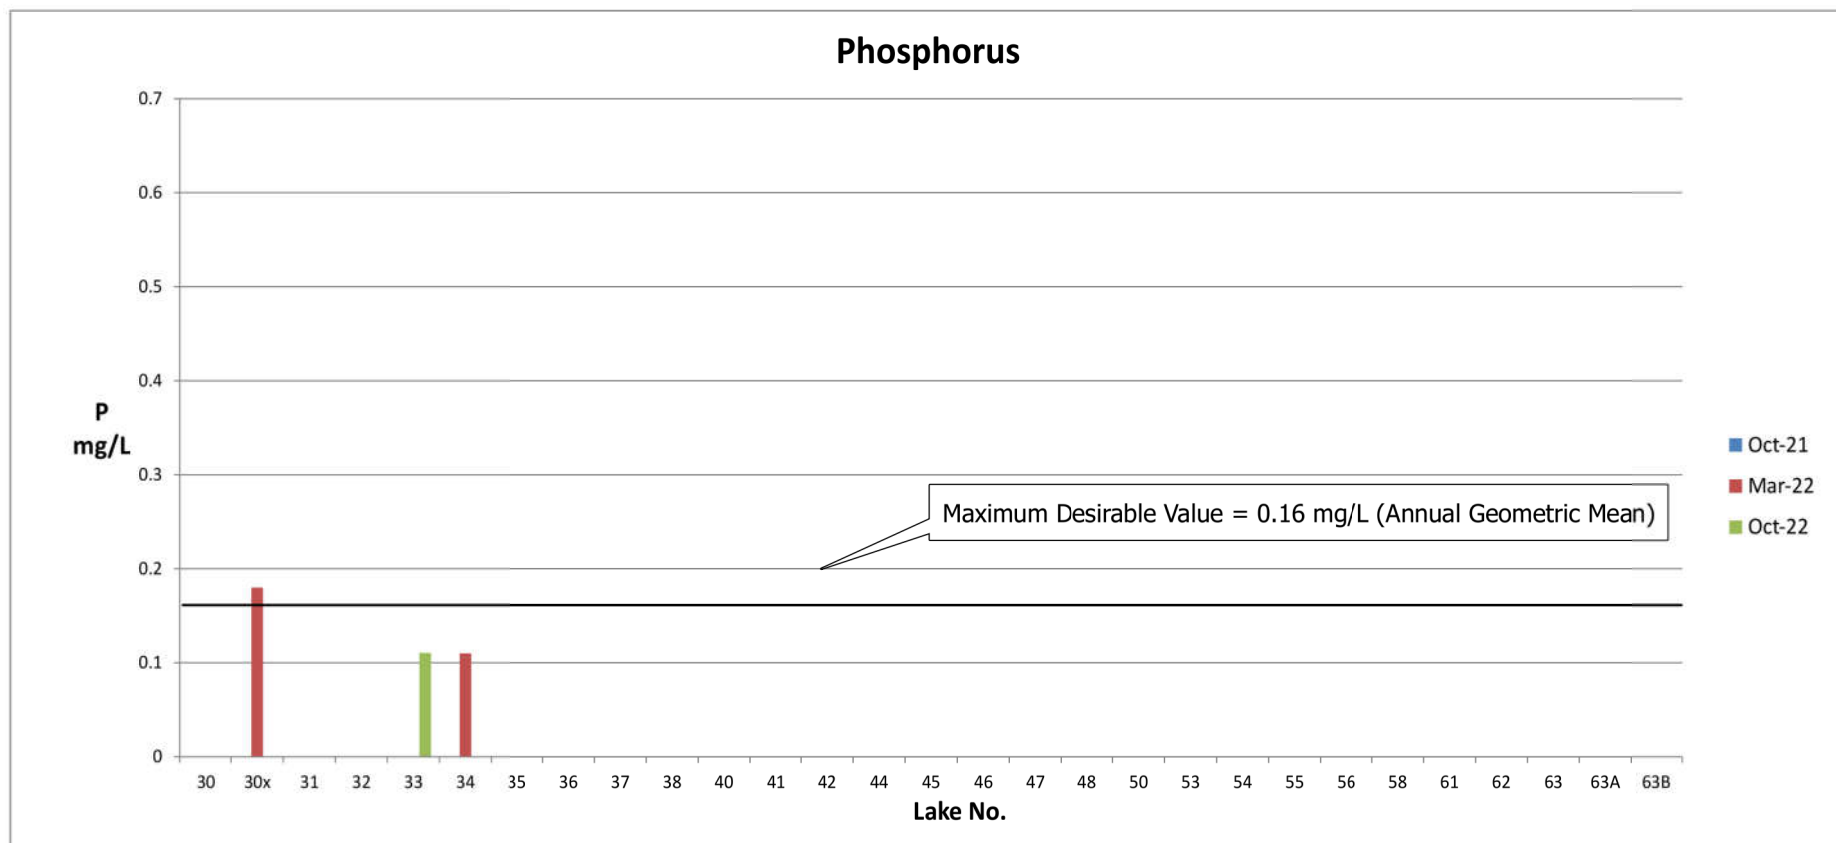
**FIGURE  
6**

The October 2022 sampling results show undetectable levels of phosphorus in all of the CDD lakes except Lake 33, which had a very low level of 0.11 mg/L. The phosphorus levels in all lakes for the last three monitoring events are shown in **Figure 6, Appendix A.**

Note: Phosphorus was not detected or was below the quantification limit in all lakes in October 2021

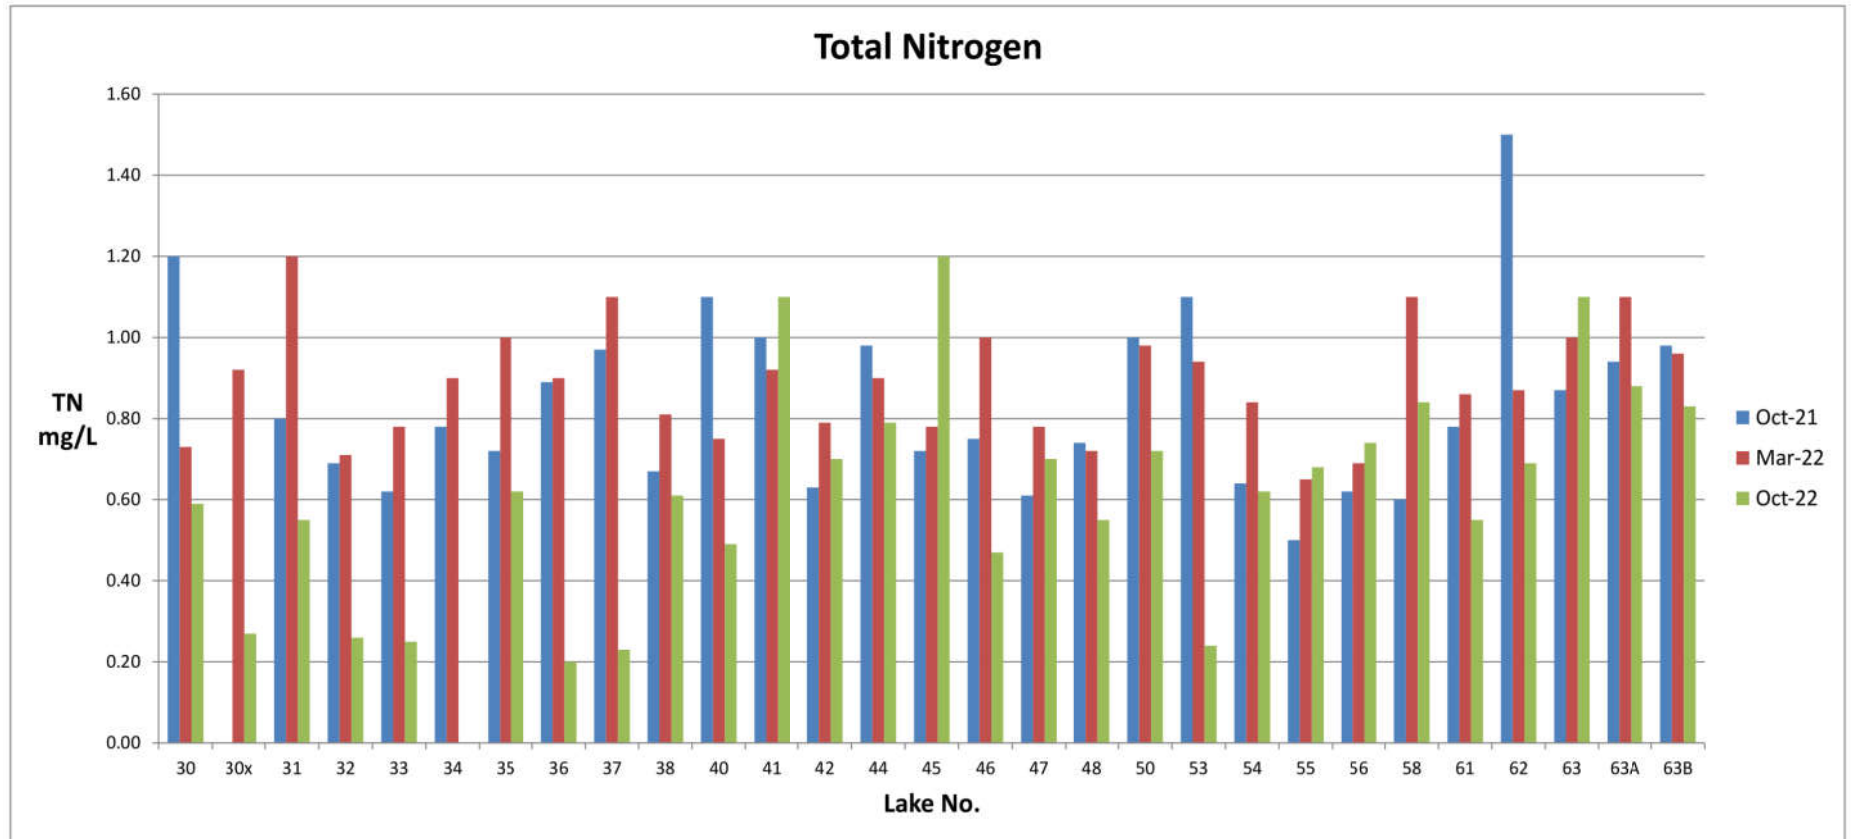
**FIGURE  
7**

In October 2022, the nitrogen levels observed in all lakes were within the normal range for Florida lakes, ranging from 0 – 1.2 mg/L. The total nitrogen levels in all lakes for the last three monitoring events are shown in **Figure 7, Appendix A**.

Maximum Desirable Value = 2.23mg/L  
(Annual Geometric Mean)

#### TOTAL NITROGEN MEASUREMENTS OCT 2021 - OCT 2022

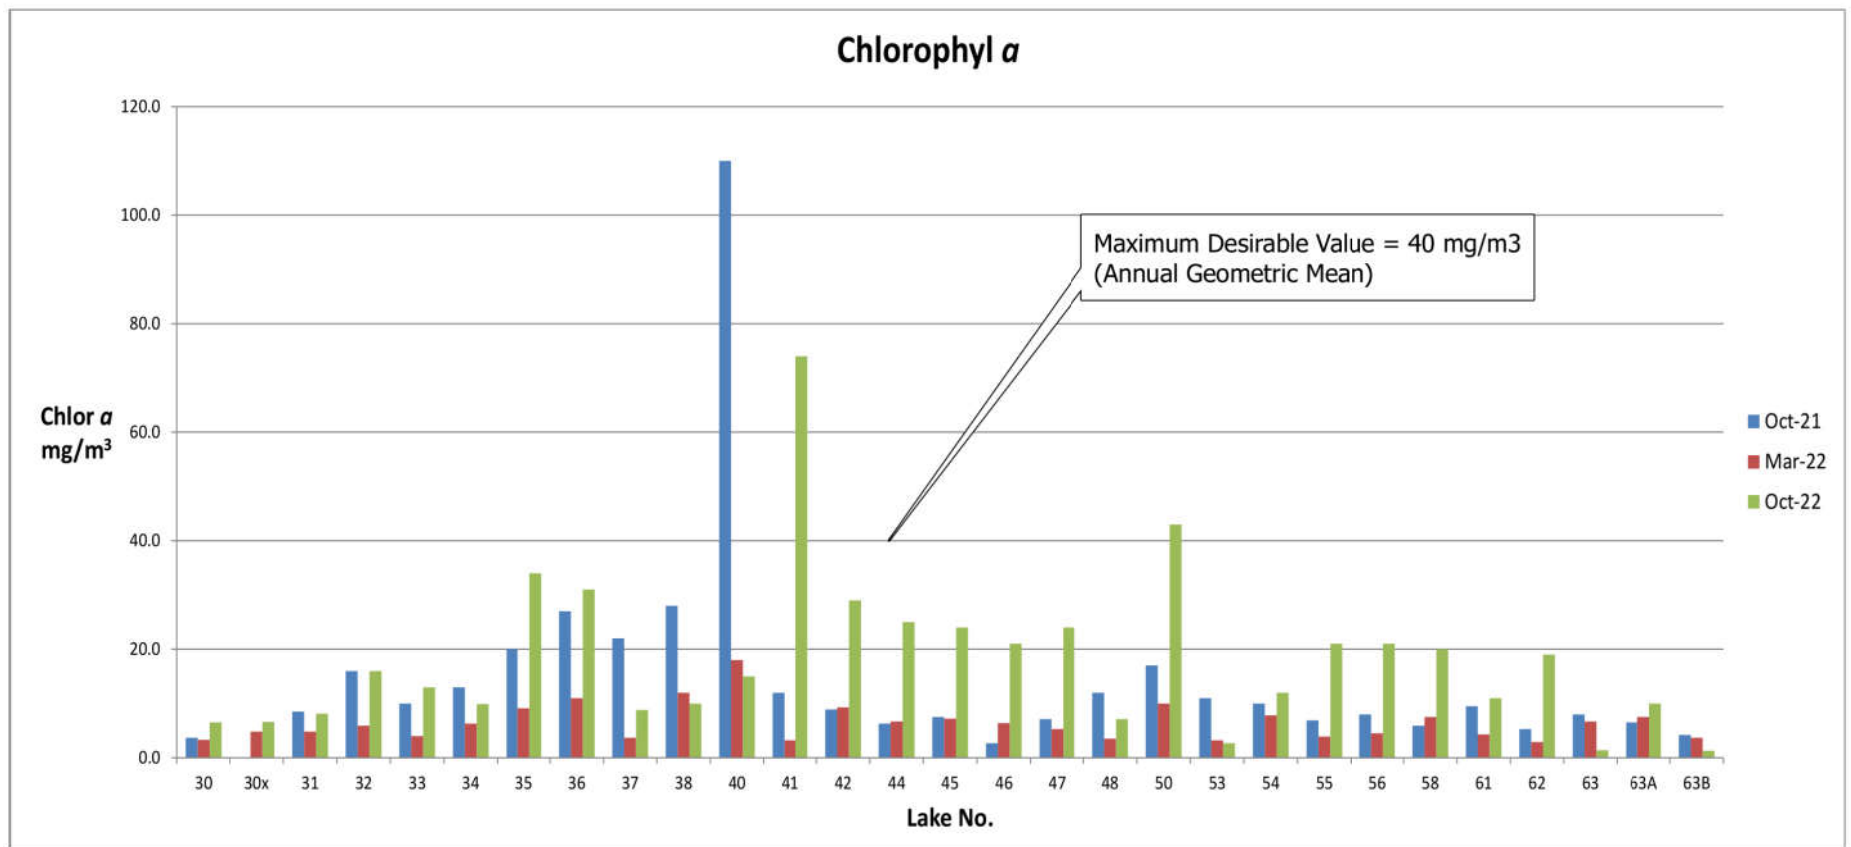
**FIGURE  
8**

#### CHLOROPHYLL A MEASUREMENTS OCT 2021 - OCT 2022

- The chlorophyll a level in Lakes 41 and 50 was above 40mg/m<sup>3</sup>. However, during the monitoring event, lake observations appeared normal and healthy. Therefore, no action is recommended at this time.
- Salinity and conductivity in all lakes were normal for freshwater lakes in Florida. Salinity values were similar in all lakes with a value of 0.1 - 0.2 ppt. Conductivity values ranged from 229 – 494 µS/cm.
- Based on visual observation, the lakes appear healthy with normal water levels and clarity. Nuisance vegetation management appears effective in the 28 CDD lakes monitored.

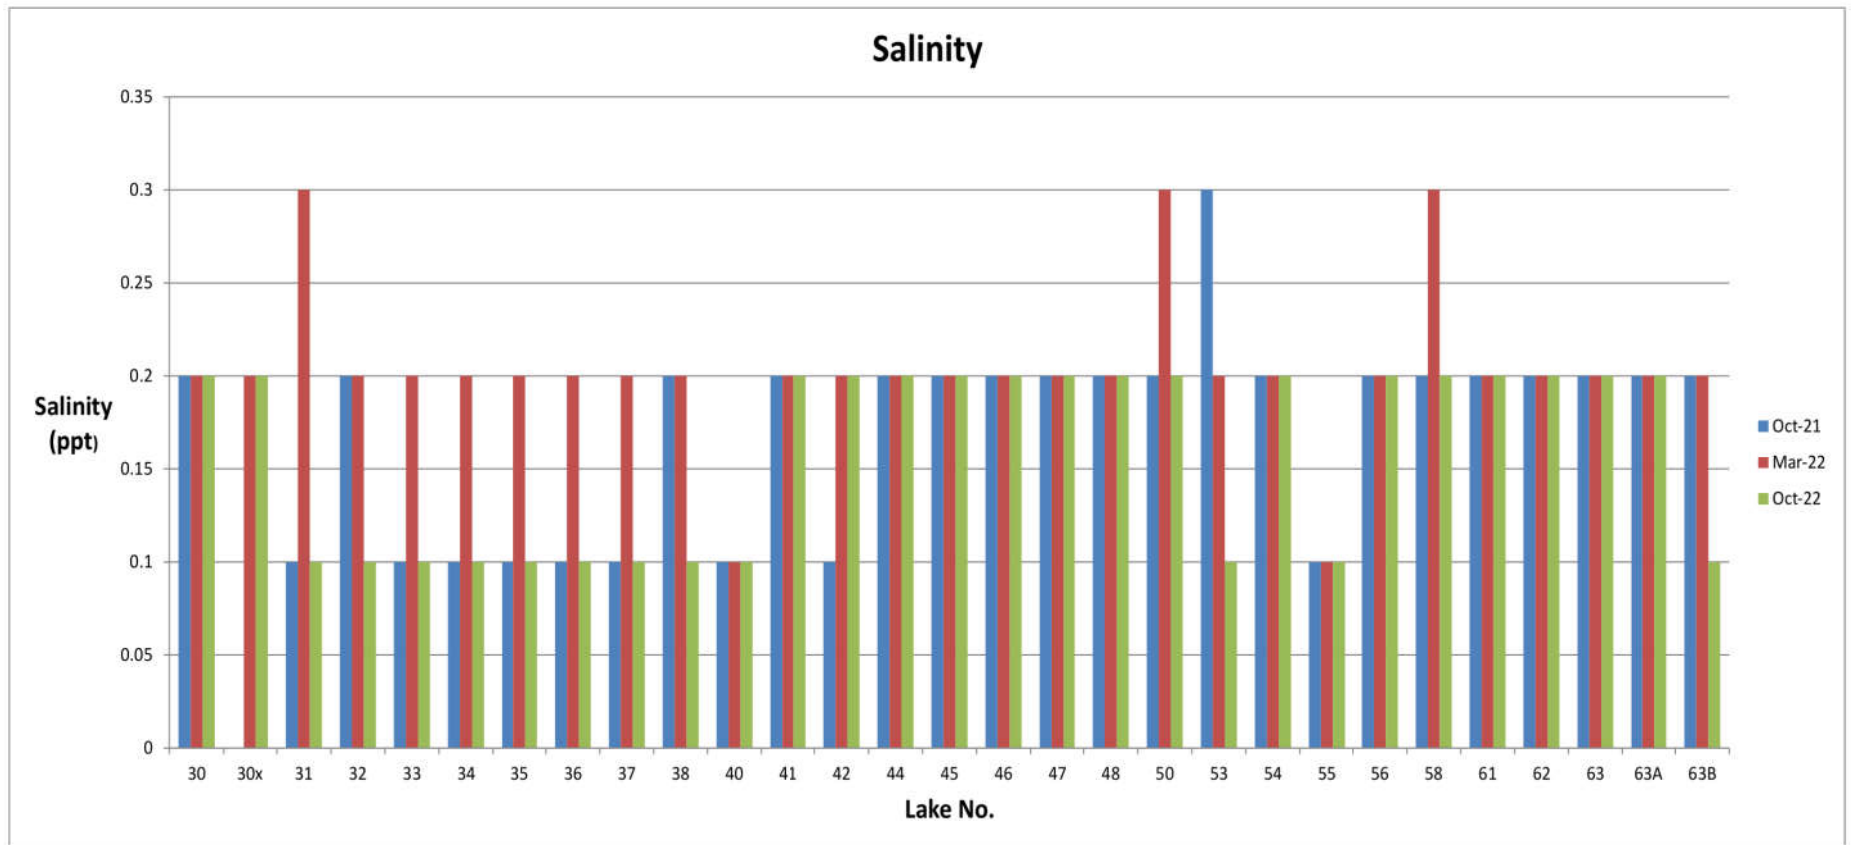
**FIGURE  
9**

The salinity found in the CDD lakes is within the normal range for man-made freshwater ponds in this region of Florida. In October 2022, salinity was low (0.1 - 0.2 ppt) as expected in all 28 lakes. The salinity measurements recorded in all lakes for the last three monitoring events are shown in **Figure 9, Appendix A**.

Normal Range = 0 - 0.5 ppt

#### SALINITY MEASUREMENTS OCT 2021 - OCT 2022

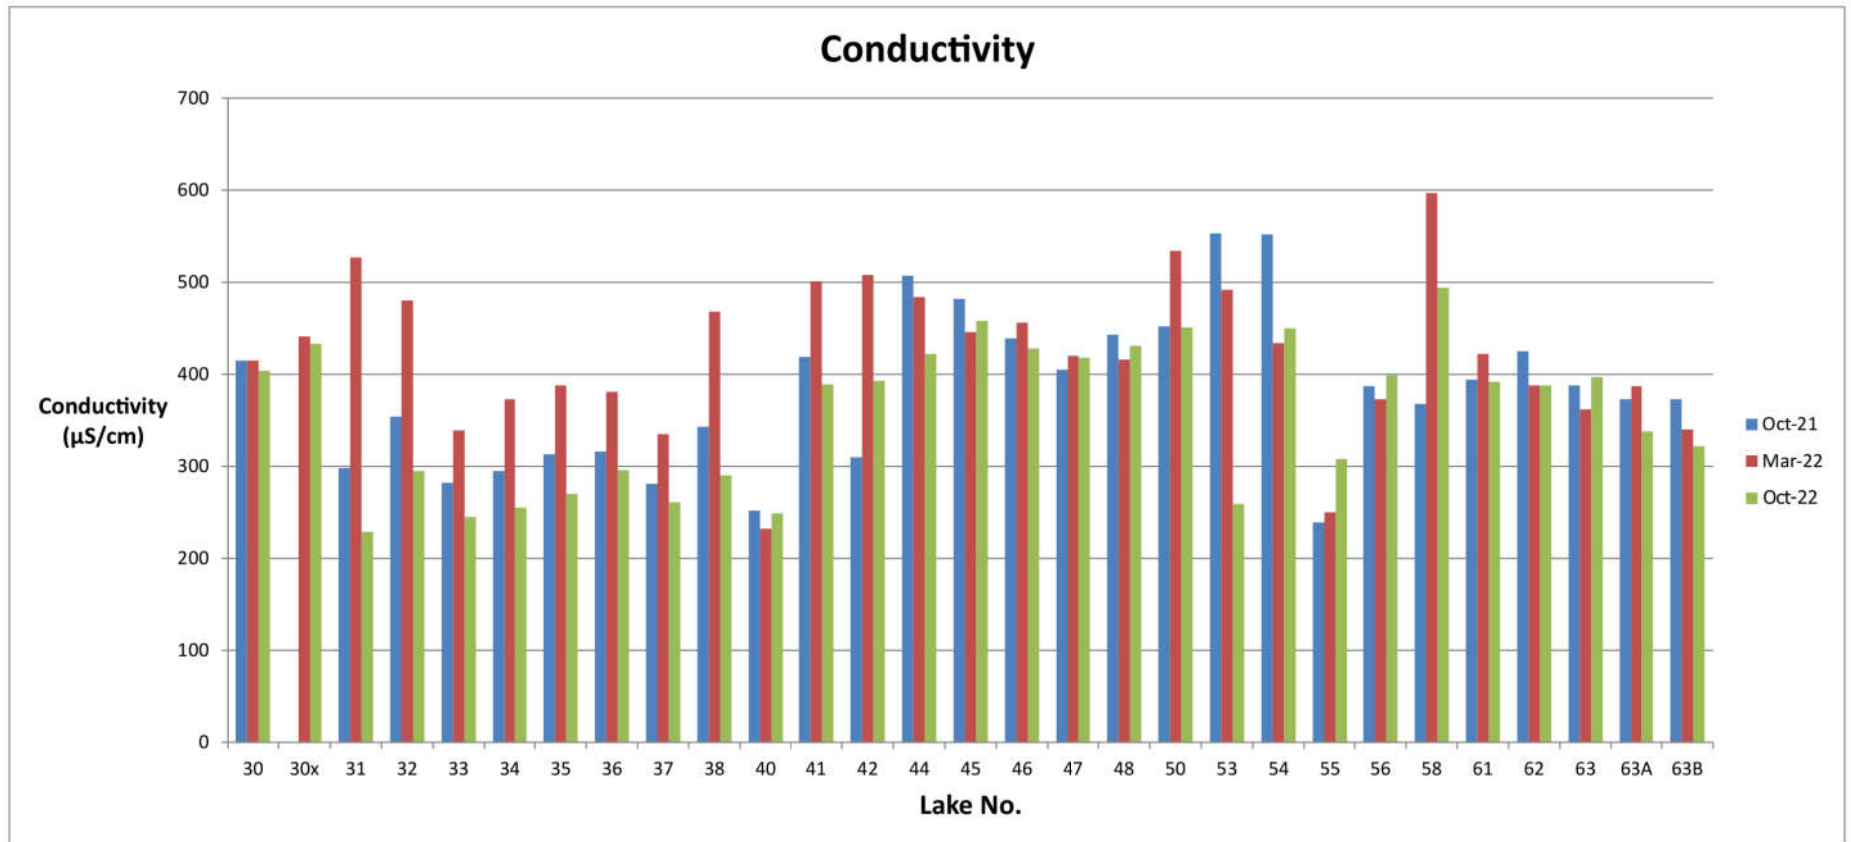
Maximum Desirable Value = 1,275 uS/cm

#### CONDUCTIVITY MEASUREMENTS OCT 2021 - OCT 2022

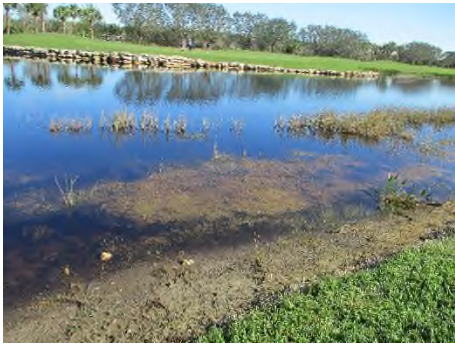
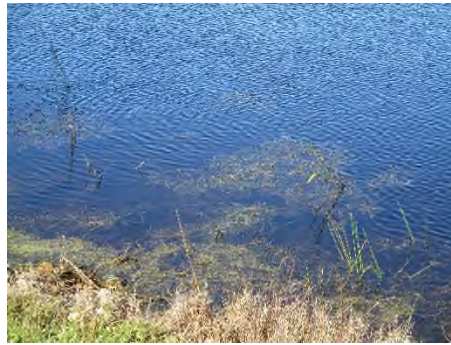
### a. Algae on Lakes: Lake 41 & 50

The lakes look healthy, water levels are receding. It was reported that Hydrilla was topping out in some lakes. This was confirmed by inspection. Alligator activity was high. Some photos were taken from a distance because of this. Additional lake maintenance information is found below; all lake issues are low density unless otherwise noted.

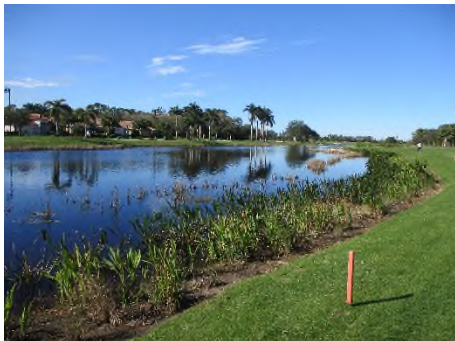
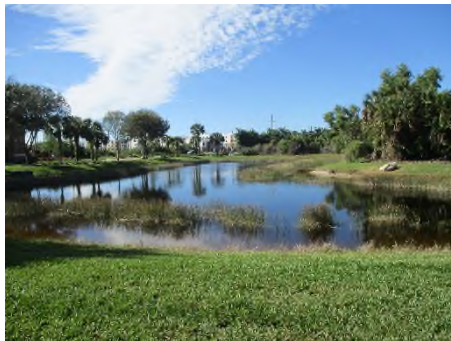
- i. The littorals in lake 40 and 50 appear to be doing very well.

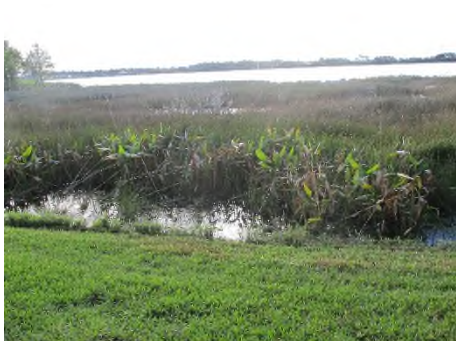
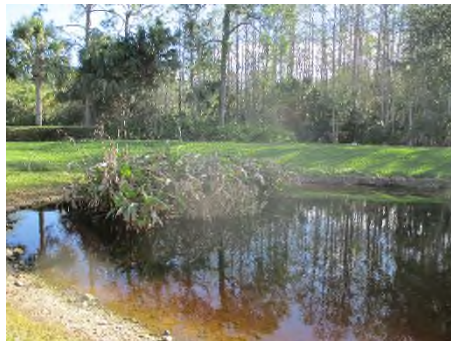
- ii. Alligator Flag in Lakes: Lakes 30 & 63. Both have appeared to have been sprayed.

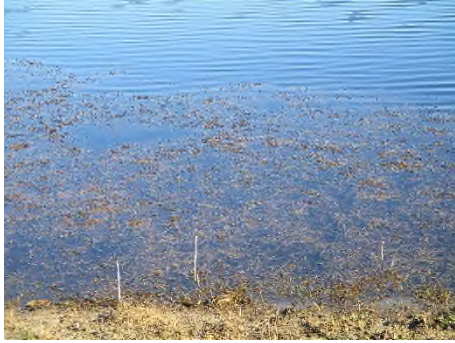
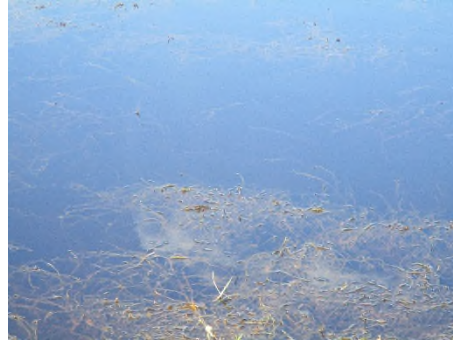
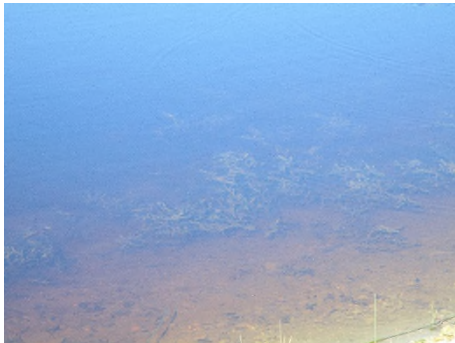
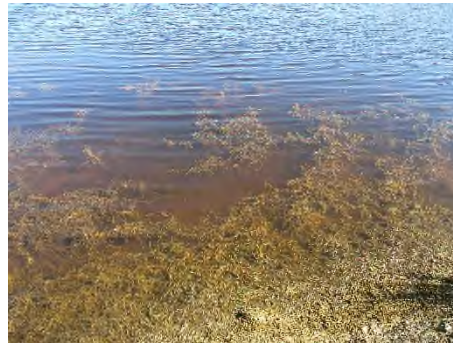
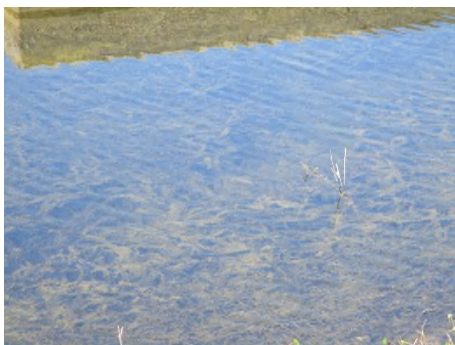
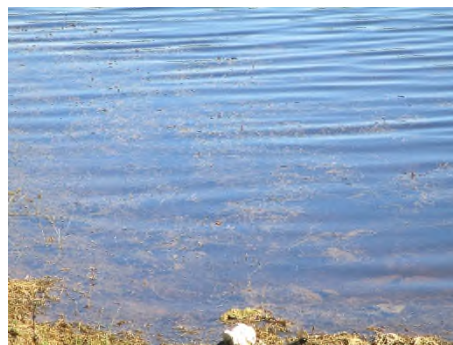
- ii. **Bitter Melon/Balsam Apple:** No issues observed.
- iii. **Brazilian Pepper:** No issues observed.
- iv. **Cattails in Lakes:** No issues observed.
- v. **Climbing Hemp Vine in Lakes:** No issues observed.
- vi. **Dollar Weed in Lakes:** No issues observed.
- vii. **Hydrilla in Lakes:** Lakes 40, 42, 54, 55, 56, 58, 59, 63A 63B

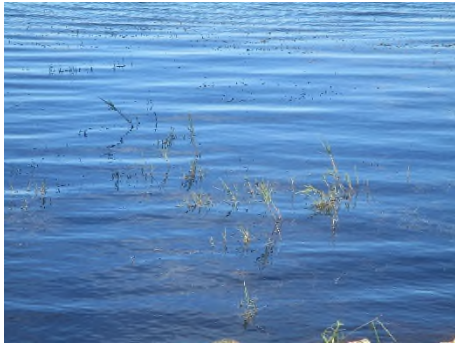
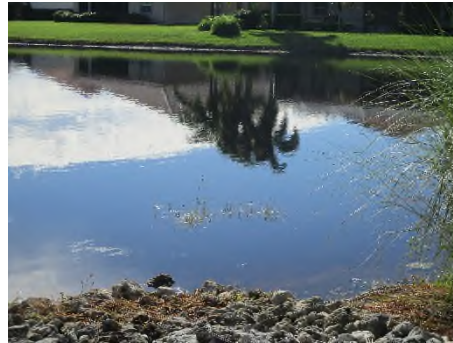
xiii. Torpedo Grass in Lakes: Lake 30 and near hole 2, lake 44

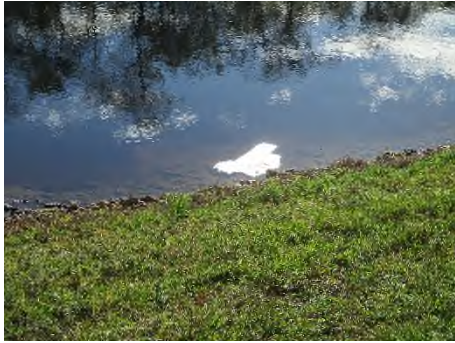
Lake 63A

xvi. Trash in Lakes:

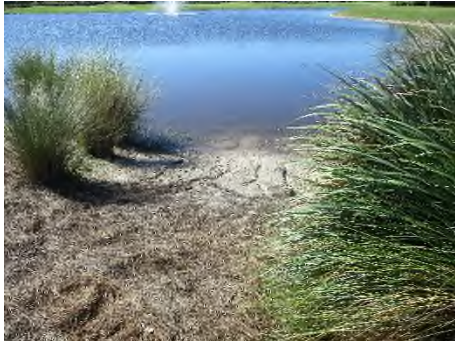
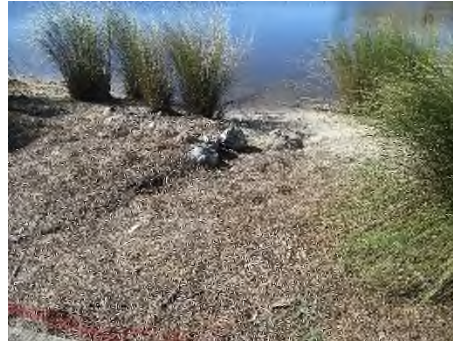
a. The erosion on lake 34 next to cart path. run off from the cart path is contributing.

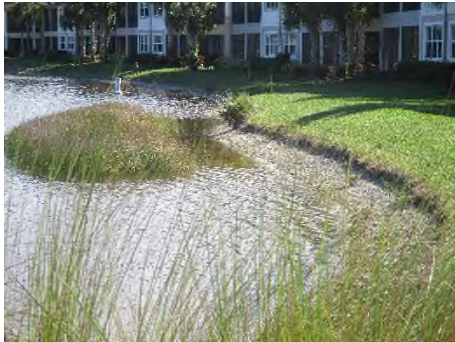
b. Step erosion observed on south bank of Lake 33.

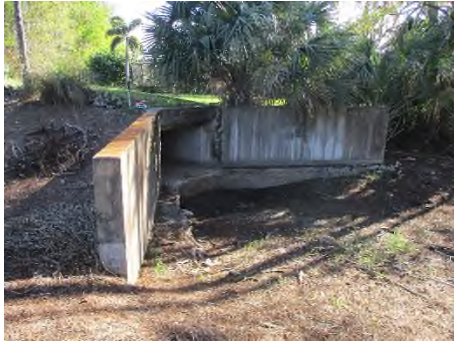
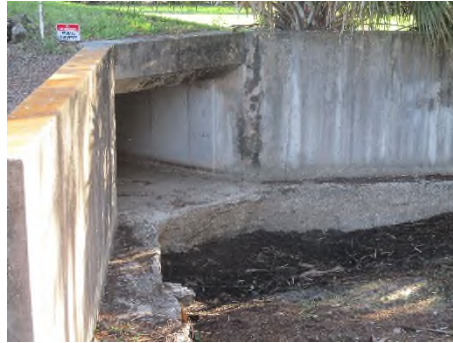
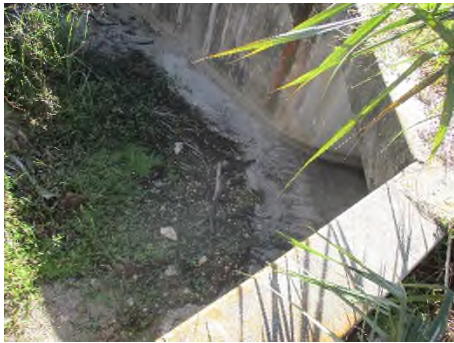
- i. **W1W2:** Control Structure near hole 5 was not flowing. Recommend evaluation of this structure while water levels are down.

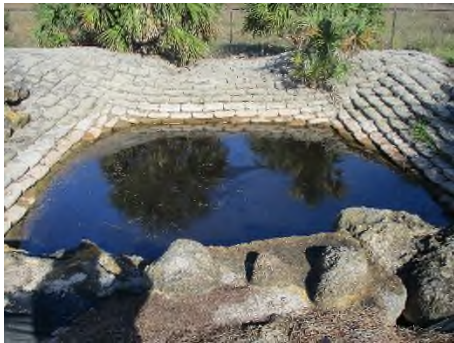
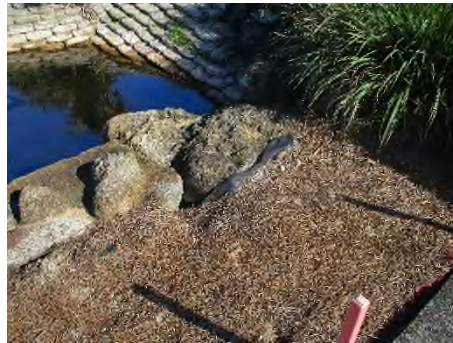
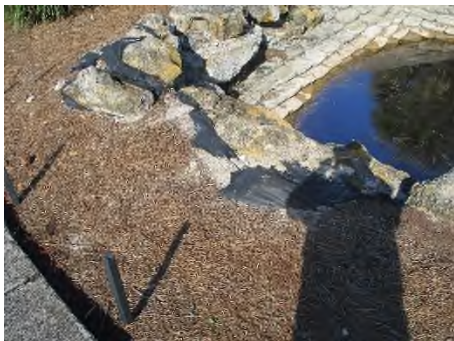
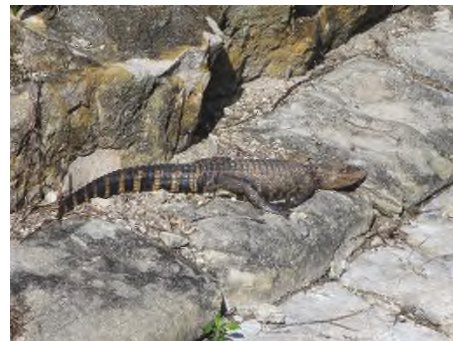
- ii. **W1W4:** The control structure was not flowing. Filter fabric is exposed in several areas. Palms and still present on the structure and removal is recommended.

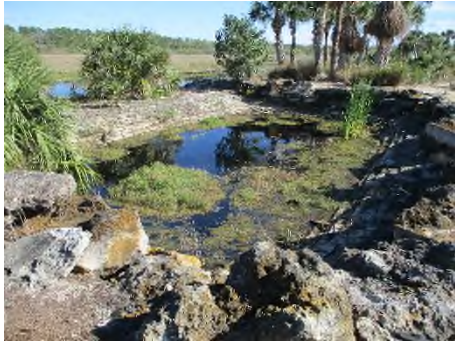
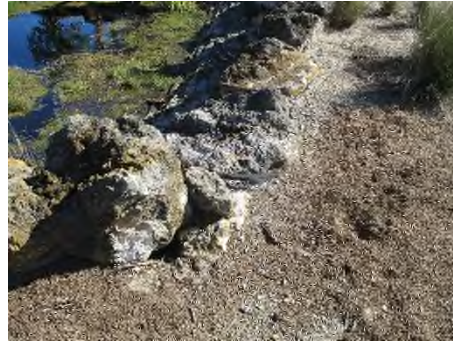
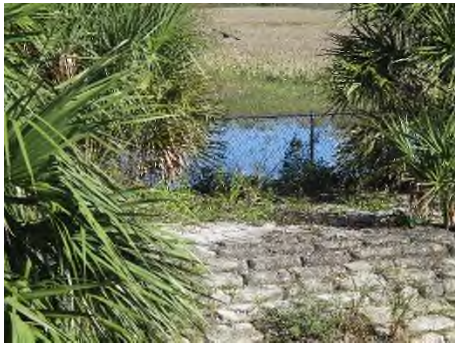
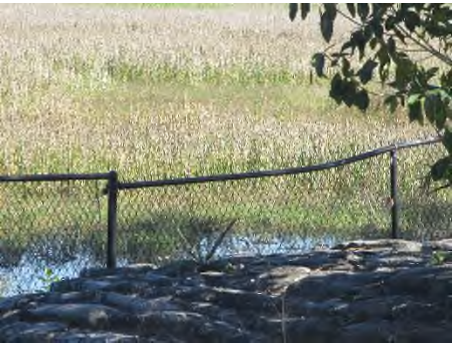
- iii. **W1L30:** Control Structure was not flowing. Weeds and palms are present. The filter fabric is exposed between rocks around the edge.

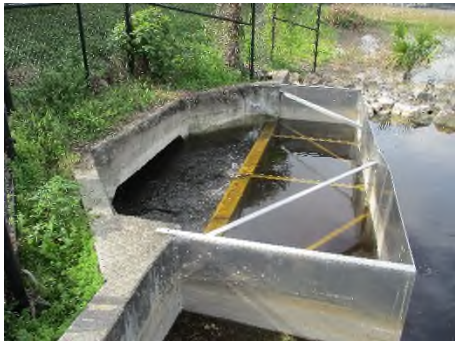
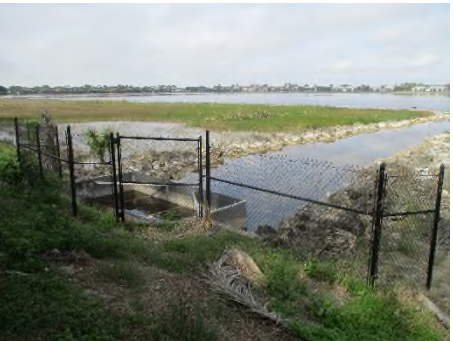
- iv. **L30COCO2:** Control Structure was flowing. Water levels are receding.

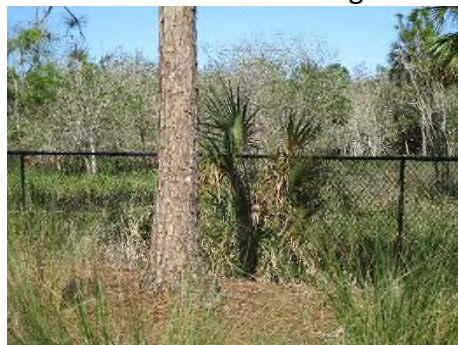
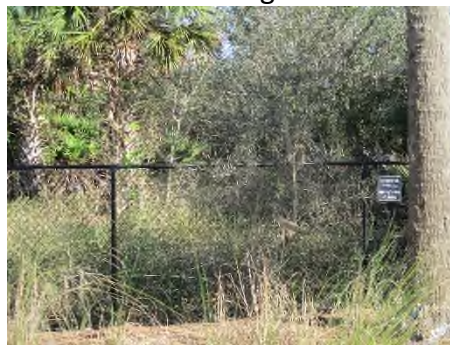
- a. The wetland fence between holes 9 and 10. It is recommended that the preserve company check the fence line for vegetation to avoid fence damage.

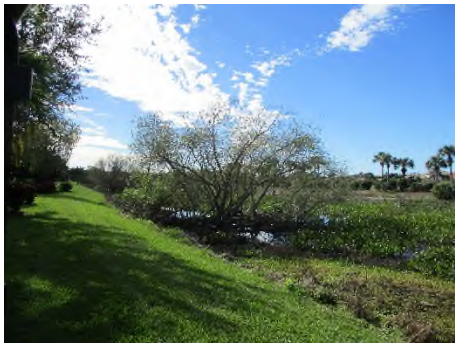
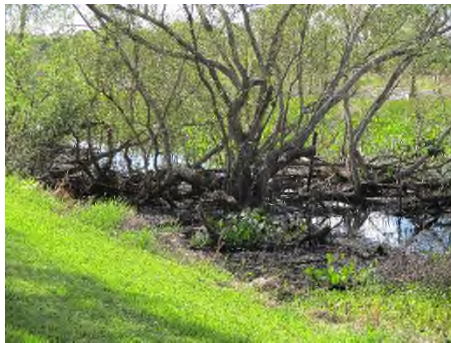
8. **Residential Complaints/Concerns:** Wetland 4 behind 9351 Marble Stone Drive. It was reported that a Willow in this location may need to be managed as to not overtake the preserve area. During inspection it appears that the root system of this tree has been cut in a few places. The board may wish to take further action on this matter. This tree is right on the preserve border.

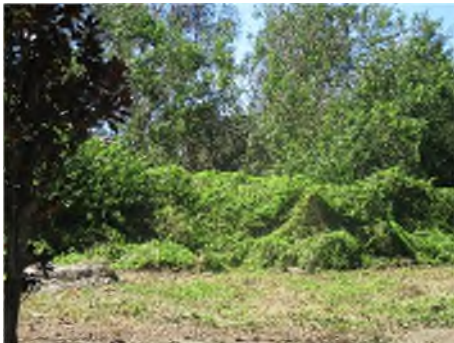
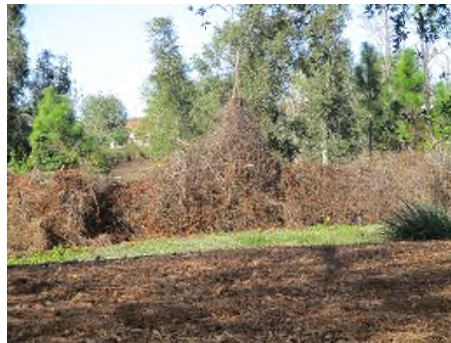
- a. Northwest corner near 11th hole. The fence is overgrown and appears to have been sprayed. It is still advised to cut and remove dead vegetation to avoid damage to fencing. Board to advise if this is the responsibility of the golf course.
