THE QUARRY COMMUNITY DEVELOPMENT DISTRICT COLLIER COUNTY, FLORIDA

STORMWATER LAKES ANNUAL ASSESSMENT REPORT MAY 2021

THE QUARRY CDD STORMWATER LAKES ASSESSMENT REPORT COLLIER COUNTY, FLORIDA

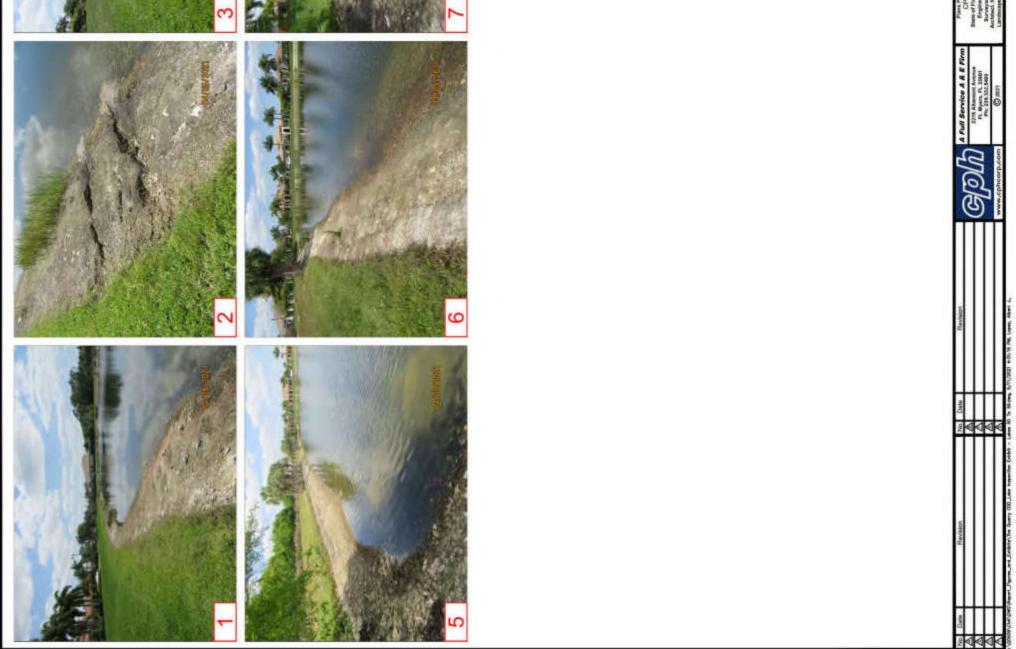
- MODERATE EROSION ADJACENT TO R.O.W. AND RESIDENTIAL PROPERTY (PHOTOS #2 & #4). APPROXIMATE 120 LF.
- RECOMMENDATIONS TO MEET ORIGINAL INTENDED DESIGN:
- RECONFIGURE 4:1 SLOPE WITH NEW FILL MATERIAL NEW FILL MATERIAL TO BE COMPACTED PER ORIGINAL DESIGN SPECIFICATIONS. .
- INSTALL 6"-8" RIPRAP LAYER AND KEY-WAY (6"-8") TO PROTECT LAKE BANK. .

- INTRODUCE THE USE OF LITTORAL PLANTING.
- THE USE OF LITTORAL PLANTING SHALL BE STARTED ON TESTING SPOTS TO CONFIRM PLANTS ADAPTATION AND SURVIVABILITY.

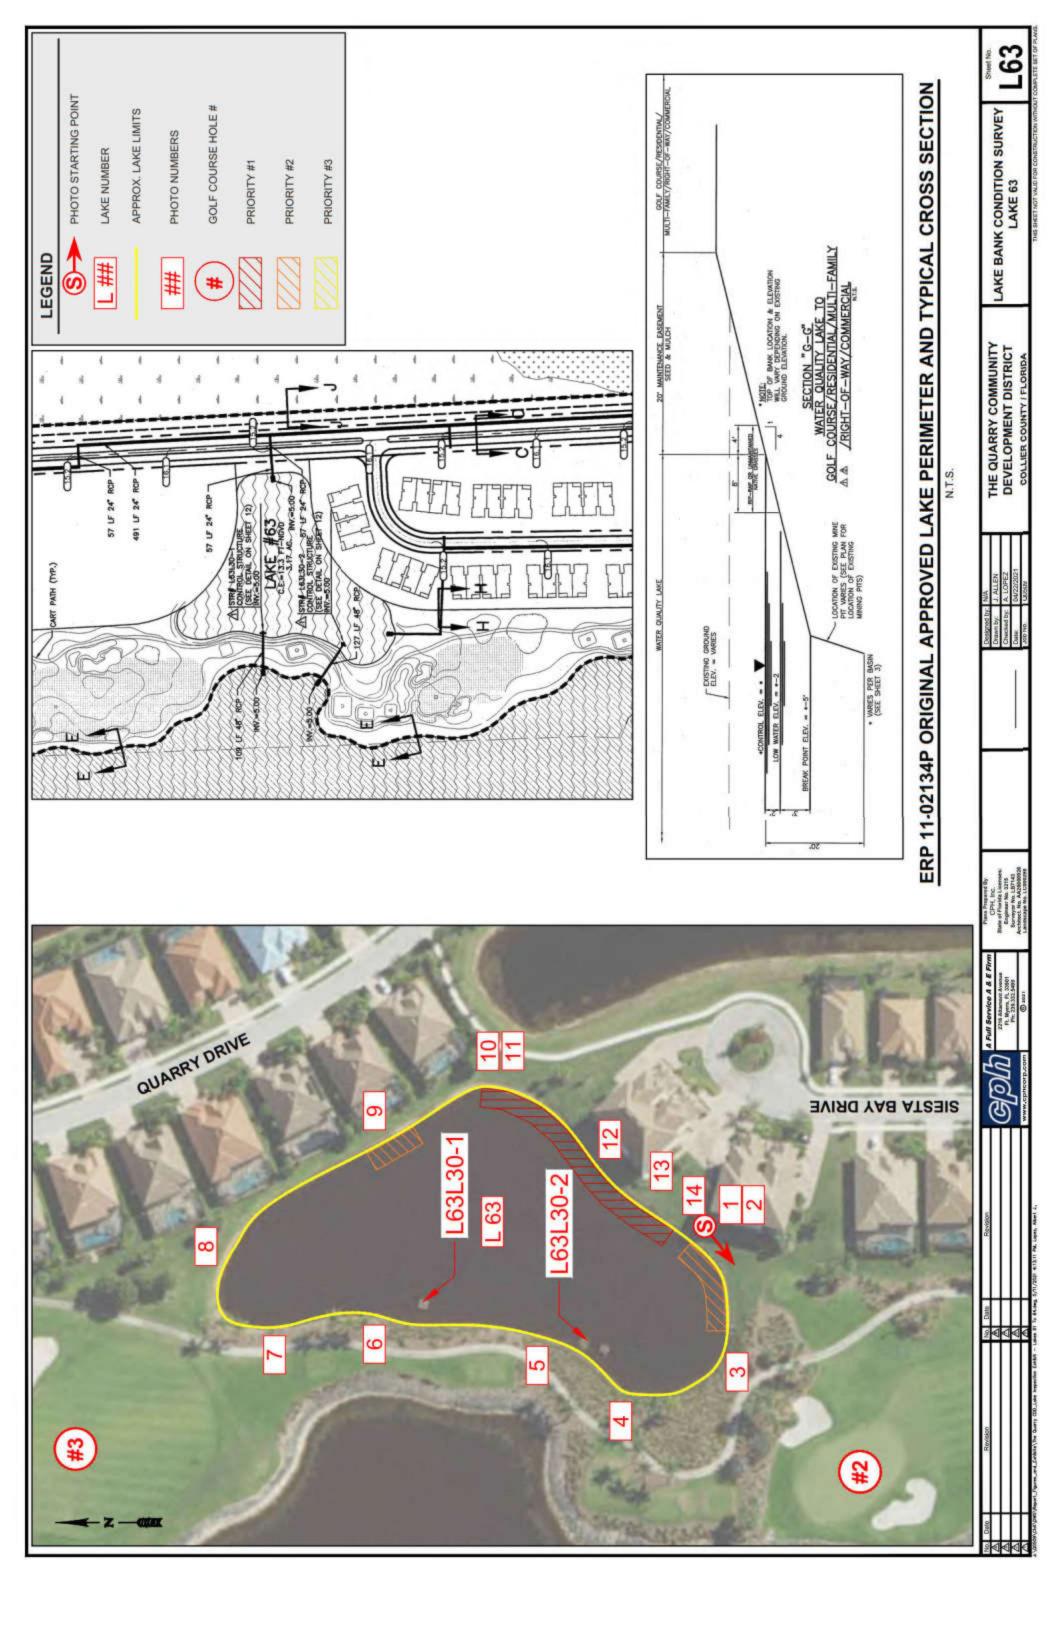
OBSERVATIONS	- MODERATE EROSION ADJACENT TO RESIDENTIAL PROPERTIES (PHOTOS #9 - #13). APPROXIMATELY 400 LF.	- CONTROL STRUCTURE (L63L30-1) TOP COVERED WITH TRASH.	RECOMMENDATIONS TO MEET ORIGINAL INTENDED DESIGN: DECOMPLICATED AT SUCCE WITH MEM FULL MATERIAL MEM	- RECONFIGURE 4.1 SLOTE WITH NEW FILL MATERIAL, NEW FILL MATERIAL TO BE COMPACTED PER ORIGINAL DESIGN SPECIFICATIONS. - INSTALL 6-8" RIPRAP LAYER AND KEY-WAY (6"-8") TO	PROTECT LAKE BANK CLEAN CONTROL STRUCTURE TOP GRATE.	ALTERNATE RECOMMENDATIONS INTRODUCE THE USE OF LITTORAL PLANTING.	 THE USE OF LITTORAL PLANTING SHALL BE STARTED ON TESTING SPOTS TO CONFIRM PLANTS ADAPTATION AND SURVIVABILITY. 	CONTROL STRUCTURE LB3L30-1		CONTROL STRUCTURE L63L30-2 260-17-101.31"N.1.81-940255.21"W	INITY LAKE BANK CONDITION SURVEY
		and the second s				4			12		
	When when he had a second and had a seco	and the second sec				3					R. R. Filmer Present Development By worken Burger Price Laconner Burger Price Action
